# Survey level two: HomeBuyer report - Survey and Valuation

Trinity Road  
Barkingside  
Ilford  
Essex

15th September 2020

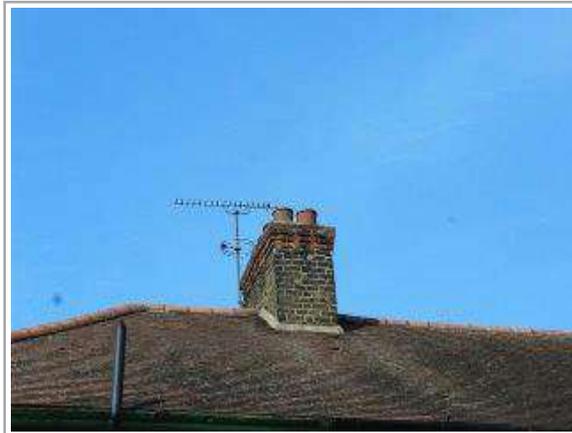
Repointing needed

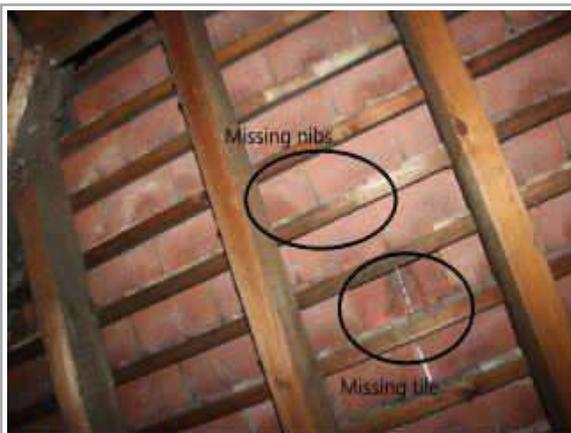
Inspection within the loft space confirms that the roof covering is now in poor condition. Many of the nibs (the small projections on the underside of the tiles, which hook over the timber battens) have cracked away.

Underside

The roof is not leaking at present, and although further leaks will probably develop due to further degradation of the tiles, it will be possible to carry out patch repairs. However, over the longer term, it will be economic to completely replace the roof covering.

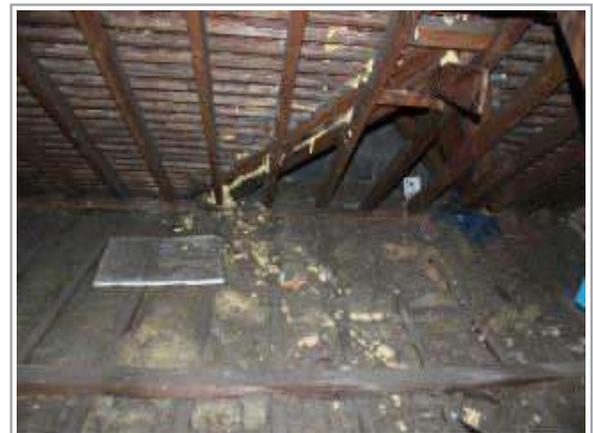
Expanding foam has been used to provide a temporary seal. However, most of this is in the area of the left valley, as seen from inside, and it is evident, from external inspection and confirmed by the vendor, that the valleys have been renewed. The tiled roofs to the left of the bay, and to the right side extending across the porch, are in similar condition.

Foam repairs

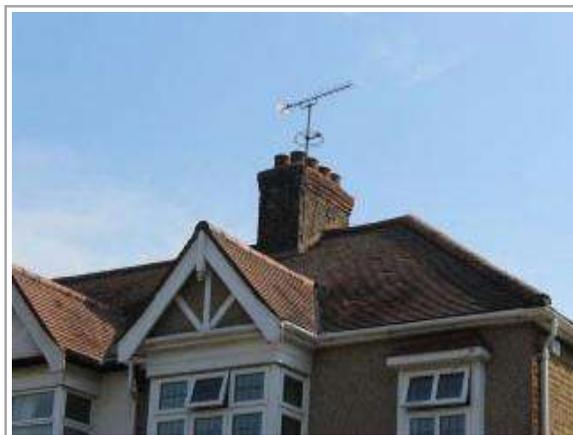
There are numerous slipped and damaged tiles, particularly as seen from the rear.

Missing tiles

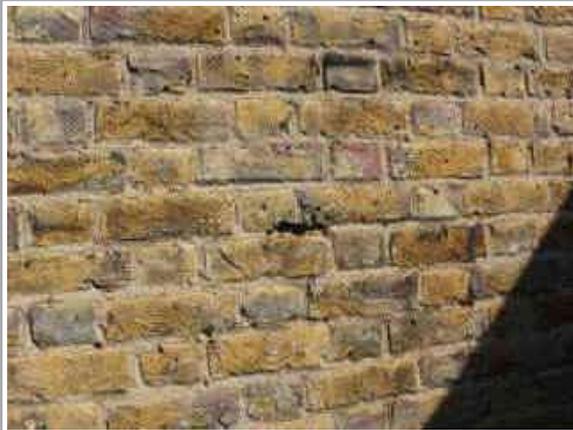
Flank

Internal and external cracking indicates that there has been some foundation settlement. The external cracking has a width of approximately 8mm, and this probably commenced soon after reconstruction of this building, which, the vendor advised was carried out about 15 years ago. Most extensions settle soon after construction, and although the extent of the cracking is more than would be expected for a modern building, it would be acceptable if there were no indications of ongoing movement.

However, the hairline internal cracking, seen at both the front and the back of the kitchen, suggests that a small amount of settlement is continuing.

The original outbuilding probably had shallow foundations, in relation to the house, and this is likely to be the reason for the continuing settlement.

Although defects of this nature tend to progress slowly, if at all, this is nevertheless a matter that has to be resolved before you can proceed with your proposed purchase. The vendor should notify the insurers, and you will need to ensure that you can continue the existing insurance policy, without exclusions or other onerous terms or charges, and with the benefit of any existing claims.

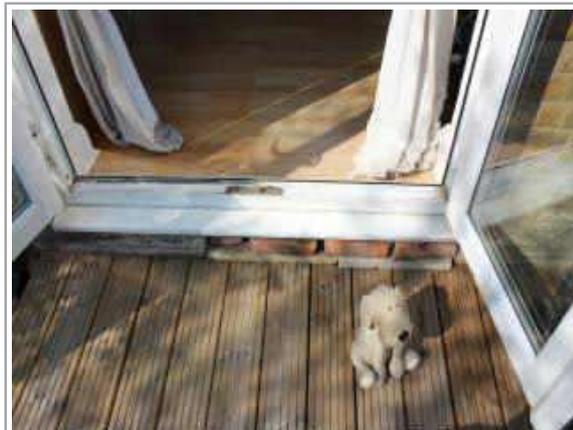
Vent needed

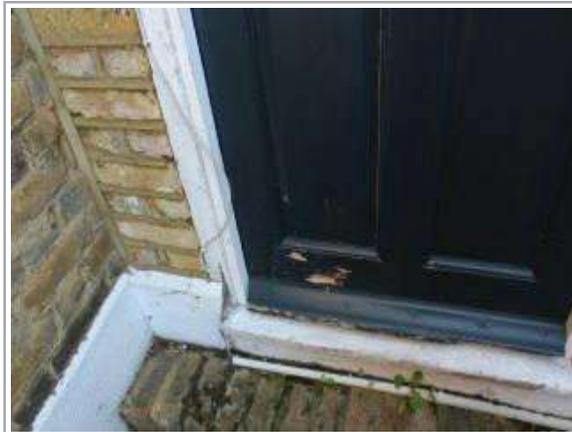
Kitchen door

The front door leading to the kitchen extension is timber framed and part glazed. It is affected by wet rot and will need to be replaced.

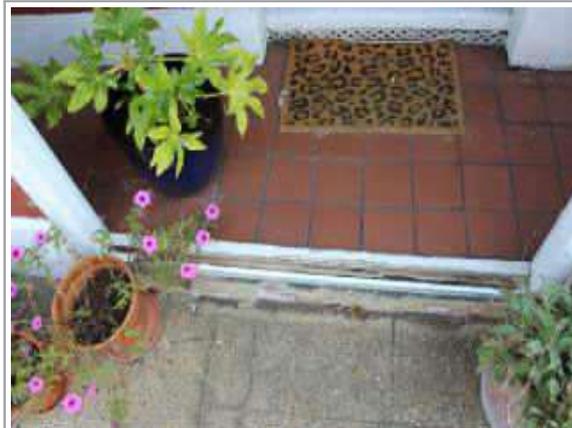
Porch threshold

At some stage, this open porch was enclosed, and some of the additional woodwork is still in place. It is in poor condition, with wet rot to the threshold and the window rails. 3

As part of the enclosure, a small brick wall was constructed at the right side. This wall was probably built directly onto the doorstep, without any additional foundation provision, and, as a result, it has settled. This is likely to be ongoing.

You will need to either construct a suitable porch or remove the redundant constructions, including this flank wall.

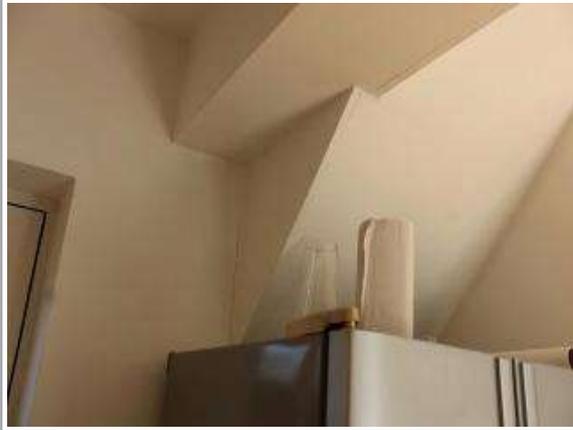
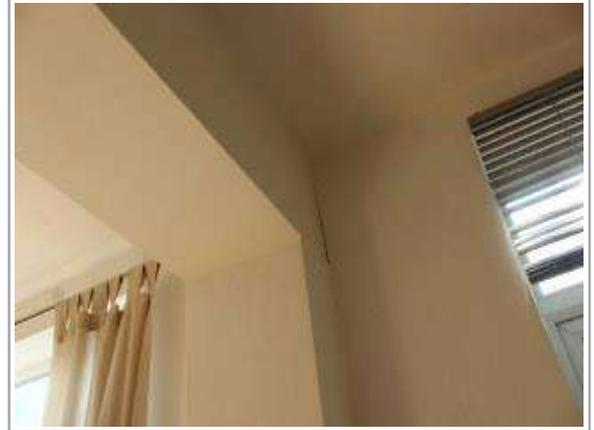
Between extension and original

The movement described in section E4 has caused a small amount of cracking in the kitchen. This is in itself a small defect, easily filled in preparation for repainting, but as noted it will be necessary to address the underlying cause.

As mentioned in Section E4, there is some cracking at the join between the original kitchen and the extension. Please refer to our recommendations in that section.

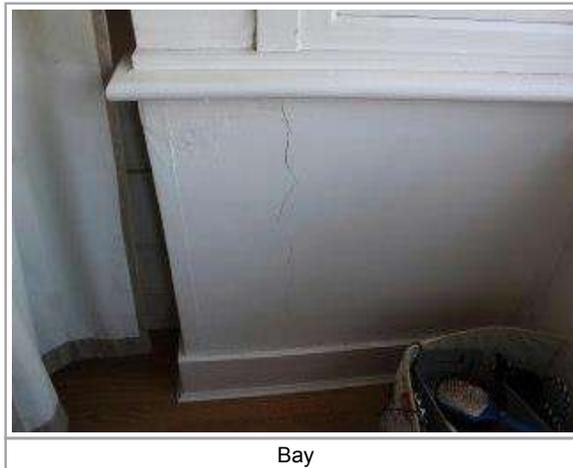
Bay

There is a crack at the left side of the front bay. This probably occurred when the windows were refitted, and it is unlikely that there is any ongoing movement.

All of the cracking is slight and may be repaired in preparation for the next redecoration, although, as in the case of the ceilings, it will be necessary to address the underlying cause of the cracking in the kitchen.

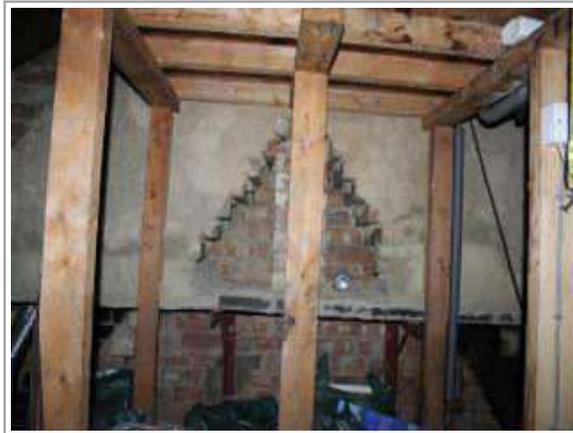
Chimney breasts removed

However, please note that some Building Control departments no longer regard such a method of support as acceptable. Furthermore, where only a small amount of chimney brickwork remains (which would arise when the adjoining owner has also removed chimney breasts) this can leave the remaining brickwork at roof level in an unstable condition. Usually, this can only be assessed by liaison with the adjoining owner.

Although there is no evidence of a repair requirement at present, it is strongly recommended that you make this enquiry. If the result indicates that the support arrangement here may be inadequate, you will need to obtain a report on required remedial work from a Chartered Building Surveyor or Structural Engineer. Please note that all such work would need to comply with Building Control requirements and Party Wall legislation.

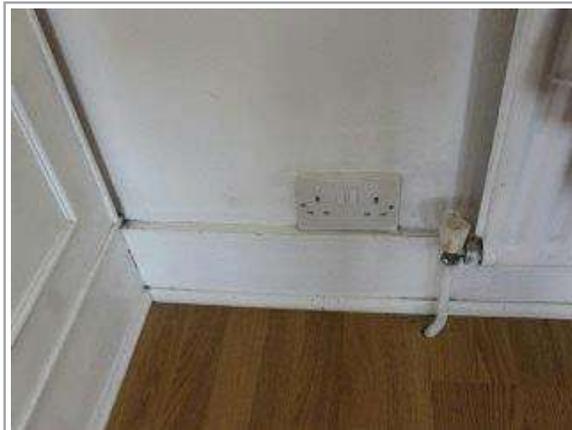
A number of socket outlets have been fitted directly above skirtings, and this may mean that some plugs or adaptors do not fit properly, which would constitute a shock or fire hazard.

Socket outlet close to skirting

Therefore, you will need to commission an electrical installation condition report (EICR) from a suitably qualified contractor (the organisations approved by the Government for the registration of electricians are NICEIC, ELECSA, NAPIT, BSI, and OFTEC).

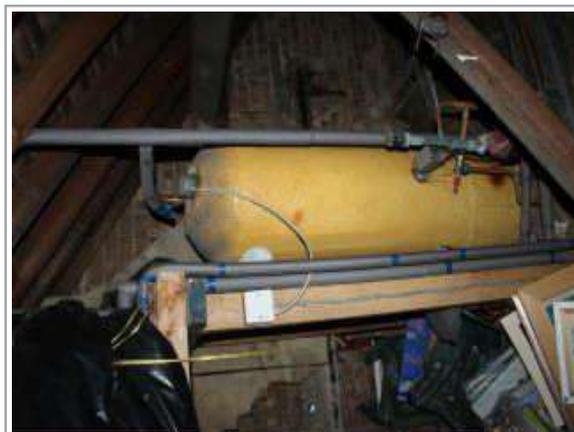
Cylinder

Hot water is provided by a cylinder, within the loft, connected to the central heating boiler. The original factory fitted foam insulation is inadequate, and will need to be supplemented by an additional jacket.

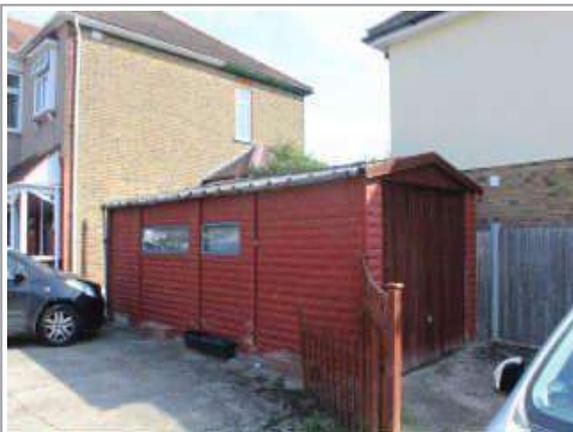
Garage

The asbestos roofing panels are in good condition, and as it is unlikely that they will be disturbed or damaged, there is no reason to arrange for their removal. However, many owners regard all asbestos materials as undesirable irrespective of risk, partly with a view to onward sale, therefore you may wish to obtain quotations for removal.

Some of the reinforced concrete panels have deteriorated, and there are cracks and signs of rust to the steel formwork. The main door has not been operated for some years, and is affected by wet rot.

All of the joinery is in poor condition and requires repainting.

Gutters and down pipes are galvanised steel. One of the downpipes has been severely damaged by vehicle impact.

Although repairs are possible this will remain a poor quality building that does not add to the amenity or appearance of the house, therefore you may wish to arrange for it to be demolished.

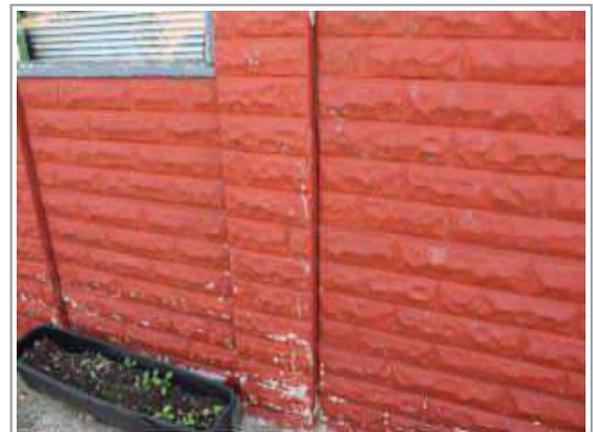
Cracked post

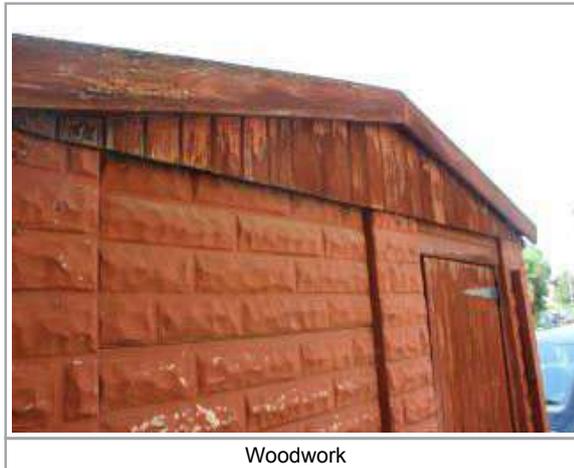
Woodwork

1. Some of the woodwork is rotten. All of the woodwork needs maintenance.
2. The flat roof is nearing the end of its life. Staining to the decking indicates that the roof has leaked in the past, and, considering its condition, it is likely to do so again. The covering should be renewed.

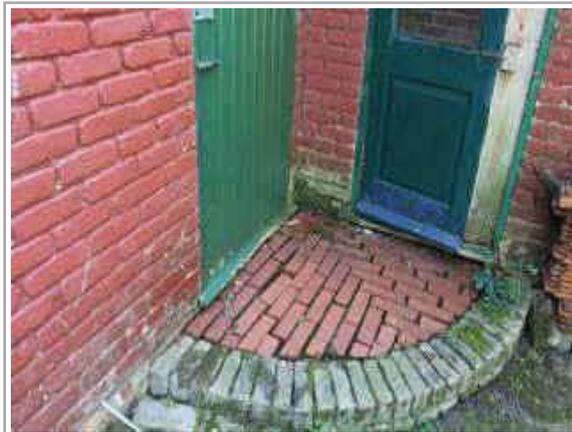
The concrete path is useable. Leading to the outbuilding, there is a step, formed with loose bricks that have not been grouted.

Grouting needed
