**BUILDING SURVEY**

**CHELSEA  
LONDON**

**RICHARD TAYLOR, BSC (HONS) MRICS**

**27<sup>TH</sup> JANUARY 2025**

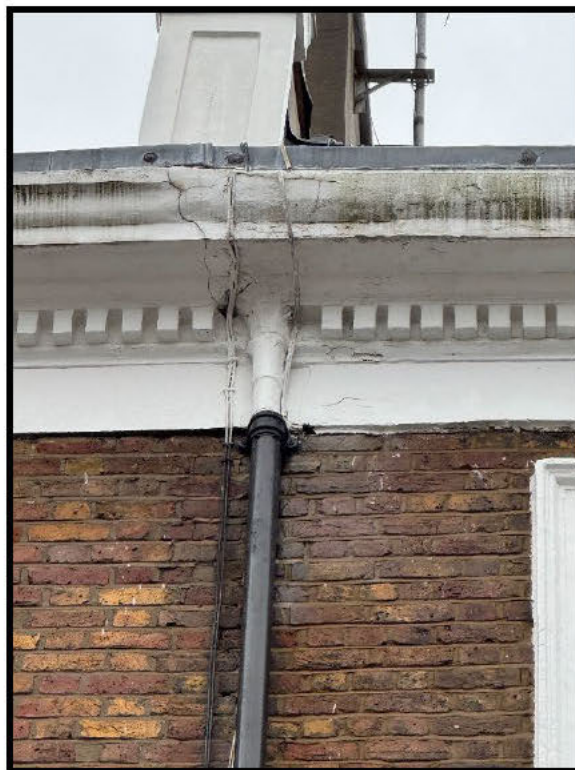
To the front elevation, the parapet gutter discharges to a cast iron hopper and downpipe to the adjoining property. Although this downpipe is the responsibility of the adjoining property, should it fall into disrepair, any water leakage could have implications for this property. The ironwork did show indications of rusting, and we recommend that it is replaced. Its fixing and securing brackets are likely to be deteriorated and it could form a falling hazard.

Cast iron hopper and down pipe to the adjoining building.

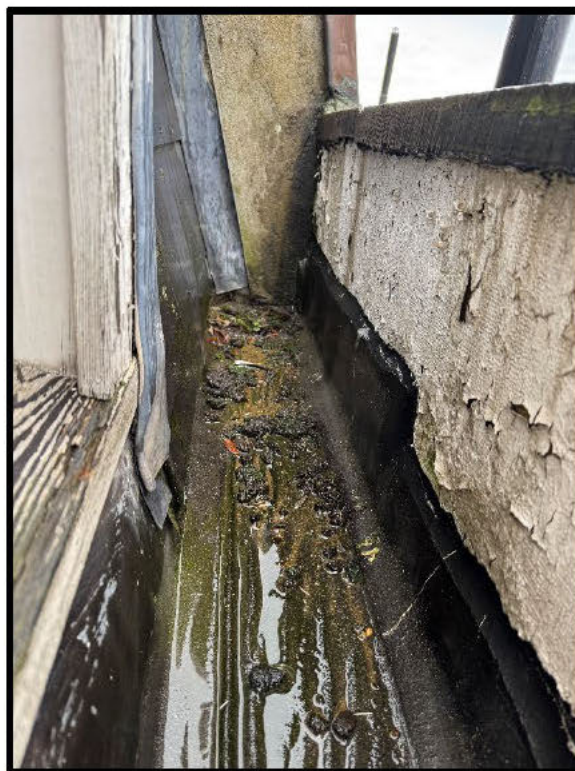
The front and rear parapet gutters are lined with sheet metal and bitumen, indicating that patch repairs/replacement have been completed in the past. Blockages were noted to both, and they must be cleared out and kept clear to allow a free flow of surface water. Water ponding could quickly lead to penetrating damp.

Part blocked parapet gutter – please note the condition of the gutter lining which is showing indications of deterioration and will form a repairing obligation in the short / medium term

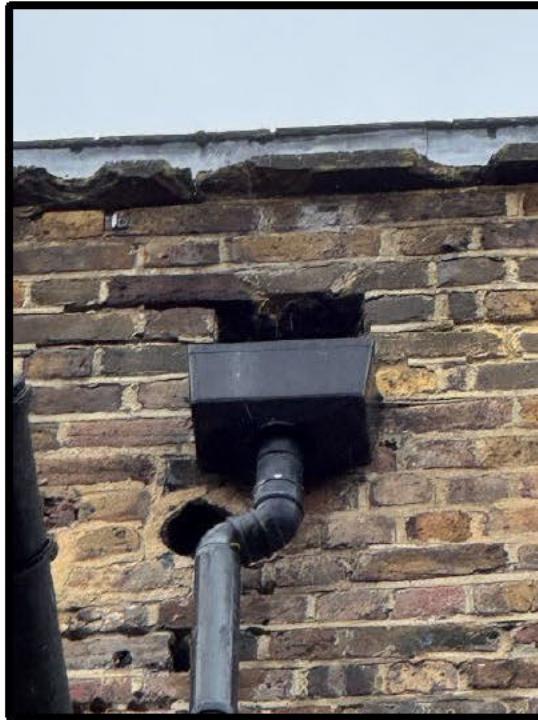
To the rear elevation, facing brickwork has in the past had repointing and repair work completed. We identified a number of individually damaged and spalled bricks which require cutting out and replacing. Weak areas of mortar joints should be raked out and renewed. At second floor, to the eaves, several sections of brickwork have been damaged where old fixings have been removed or where pipes have been relocated. Repairs must now be completed to prevent penetrating damp. It is clear that the rear four storey projection is not original to the building, with this projection having been partially rebuilt in the recent past. Its facing brickwork is a satisfactory colour match to the original building, and no significant signs of disrepair were identified.

Damaged brickwork – note circular hole where it appears a pipe, probably from the surface water drainage system, has been removed.  
Also note damaged stonework to the parapet which requires renewal.

Main walls are taken up as parapets at roof levels. They are stone and render finished. The rear parapet wall is stone capped, but several sections of the stonework are damaged and deteriorating and should be replaced. In their present condition, they could allow localised penetrating damp. To the front elevation, the parapet wall is render and paint finished and is dressed in lead.

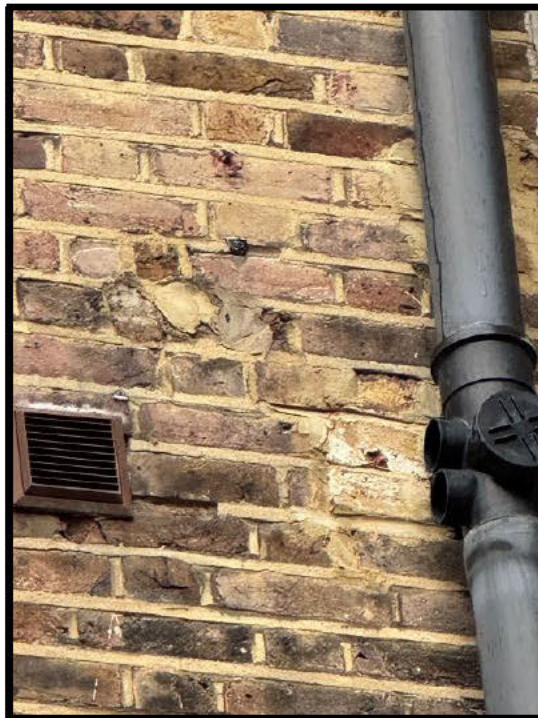
Damaged upper brickwork to the rear elevation

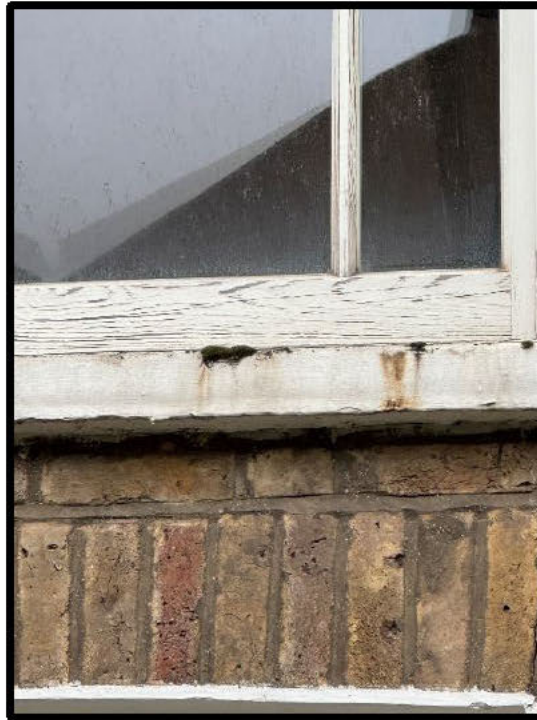
We would comment that decorations to the stone/rendered sills to the windows at the rear of the building were in only fair condition. They require repainting. When this work is undertaken, any areas of damaged render/stonework should be repaired as found necessary.

Poor decorations and damaged sill to the rear elevation

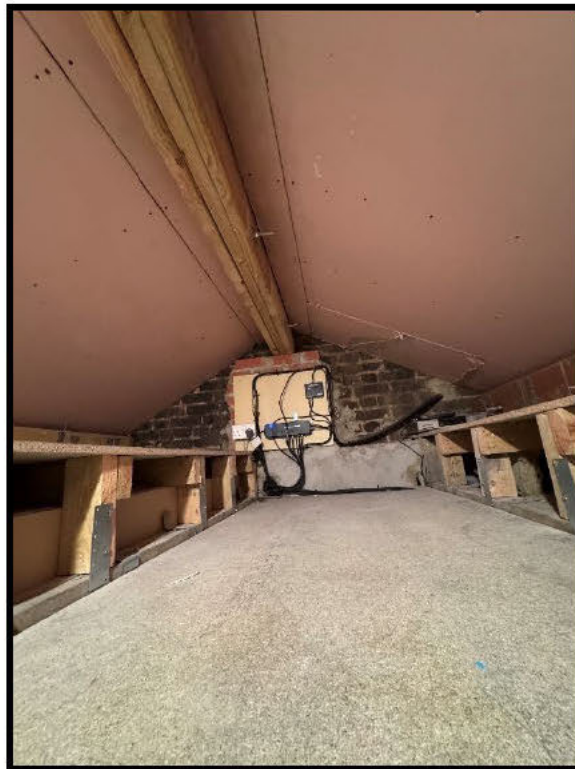
Roof void

The roof frame is of timber design, however, our inspection was very restricted due to the presence of plasterboard panelling having been adopted to the undersides of the rafters. There appears to be some provision of insulation provided by fibre quilt, but this does not appear to have been laid to the whole of the roof, and there is no provision to the access hatch. We recommend that further quilt insulation is fitted, to a depth of 350mm / 400mm.

The original frame has been strengthened, with replacement purlins and the frame supported by new intermediary supports incorporating mild steel straps.

We have not completed any calculations, and our view of the frame was very restricted, but it showed no obvious signs of defect.

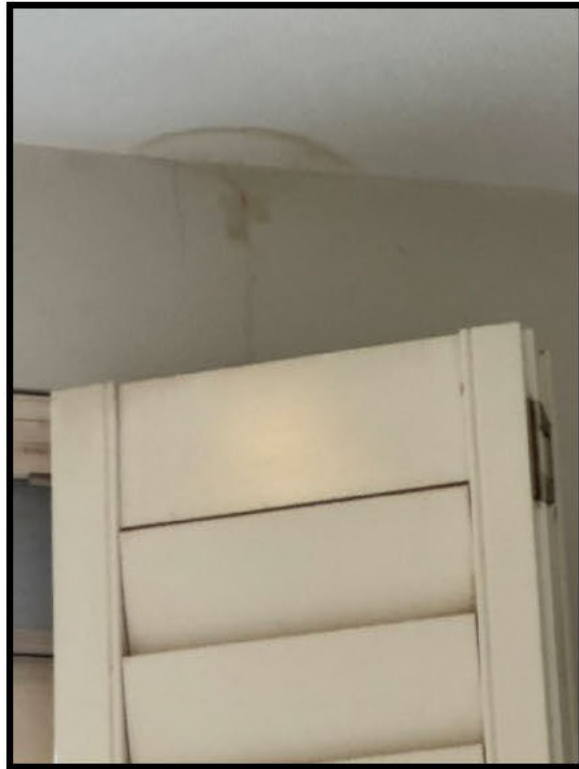
Penetrating damp was also identified to the ceiling of the ensuite bathroom to bedroom one. When tested with a moisture meter it was shown to be dry, but further investigations are required to track down the source of this damp.

Damp stain to ensuite bathroom ceiling

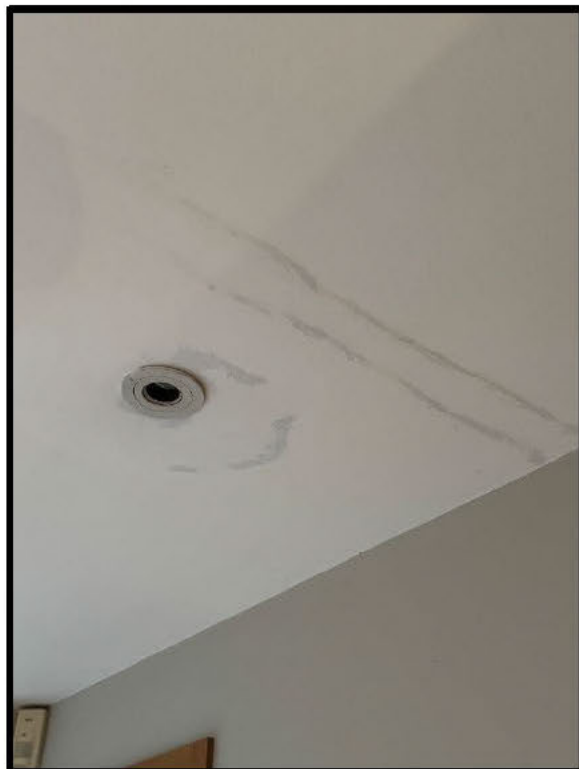
To the rear breakfast room directly below the boiler storeroom, the ceiling is damp damaged. When tested with an electrical moisture meter, the stains were found to be dry, indicating that this is an old problem. Nevertheless, the ceiling at the very least requires repainting. It is unsightly, and the vendors should be approached for confirmation as to the cause of this damp issue.

Damp stain to breakfast room

Evidence of previous penetrating damp was identified to the ceiling of the breakfast room, and further investigations should be undertaken. However, as previously reported, when tested with an electrical moisture meter, the stains were found to be dry, indicating that this is an old issue.

To the rear raised ground floor, there is a store cupboard housing the hot water tank and gas boiler. Note the floor to this cupboard is damp stained. This is directly above the damp damage to the breakfast room ceiling, indicating an old leak from the adjoining plumbing.

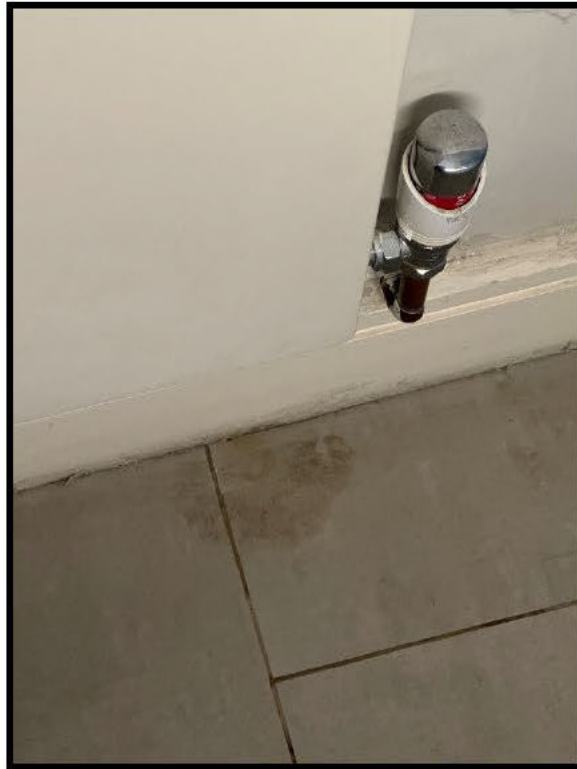
We noted radiators have been removed and where some have previously leaked.

Radiator showing indications of leakage believed to be an old issue but should be monitored

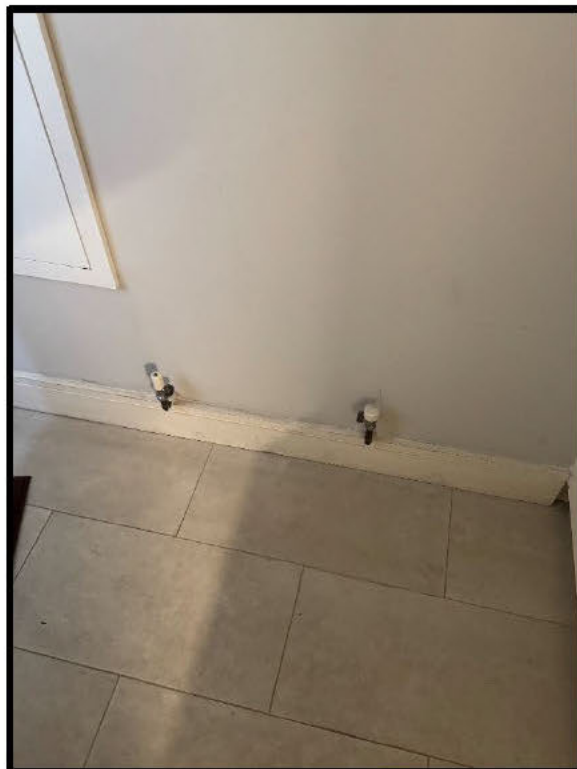
Removed radiator
