**BUILDING SURVEY**

**CHELSEA  
LONDON**

**RICHARD TAYLOR, BSC (HONS) MRICS**

**27<sup>TH</sup> JANUARY 2025**

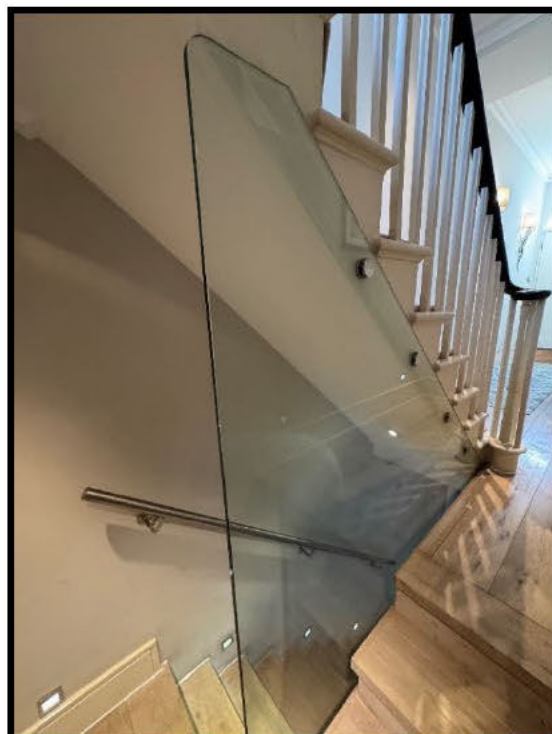
Glass panels

As a feature, the stairs leading from the raised ground to lower ground floor have reinforced glass panels as a partition, with a fixed Perspex window between the raised ground floor rear hall and the rear living room. These features provide additional natural light to an otherwise dark area of the property.
